# Army Lodging Wellness Recommendation

## Fort Bragg - Final Submittal

August 15, 2003

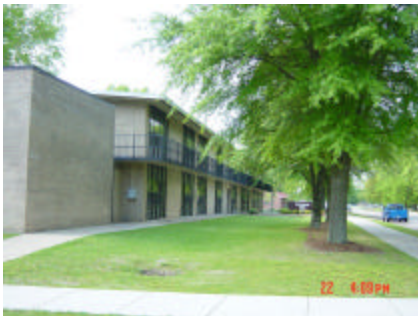
### ***Lodging Building 1-4425 (Sink)***

Building 1-4425, constructed in 1931, is a single family suite with 2 bedrooms, living room, sun room, den dining room and kitchen. The building is in poor condition and does not meet Lodging standards. The cost to make condition assessment improvements will exceed the 50% replacement cost.

Our recommendation is to remove 1-4425 from the Lodging inventory, allowing the installation to determine an alternate use for the facility. This facility will be removed from the Fort Bragg Wellness Solution and Lodging Master Plan.

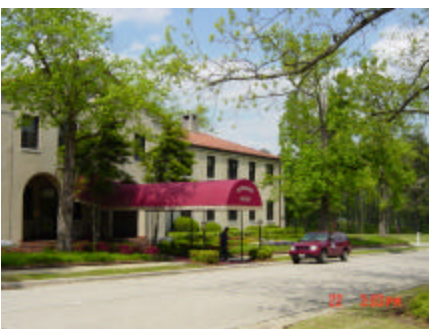
Building 1-4428, constructed in 1935, has 2 standard and 18 multi-room suites. The building is in poor condition and does not meet Lodging standards. The cost to make condition assessment improvements will exceed the 50% replacement cost.

Our recommendation is to remove 1-4428 from the Lodging inventory, allowing the installation to determine an alternate use the facility. This

facility will be removed from the Fort Bragg Wellness Solution and Lodging Master Plan.

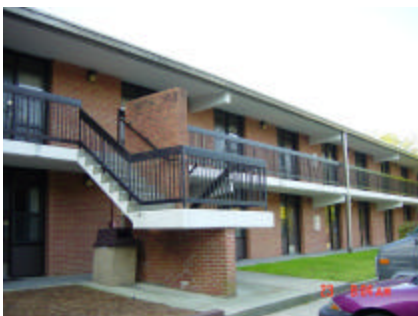
Building D4215, constructed 1971, has 74 extended stay rooms. This facility is in poor condition and does not meet Lodging standards. The cost to make condition assessment improvements exceed the 50% replacement cost.

Our recommendation is to remove D4215 from the Lodging inventory, allowing the installation to determine an alternate use for the facility. This facility will be removed from the Fort Bragg Wellness Solution and Lodging Master Plan.
